# **Instrument for Damage Evaluation/Characterization of Steel Belted Radial Tires**

FINAL PROGRESS REPORT

**Henrique L. M. dos Reis  
Paul J. Golko**

February, 1996

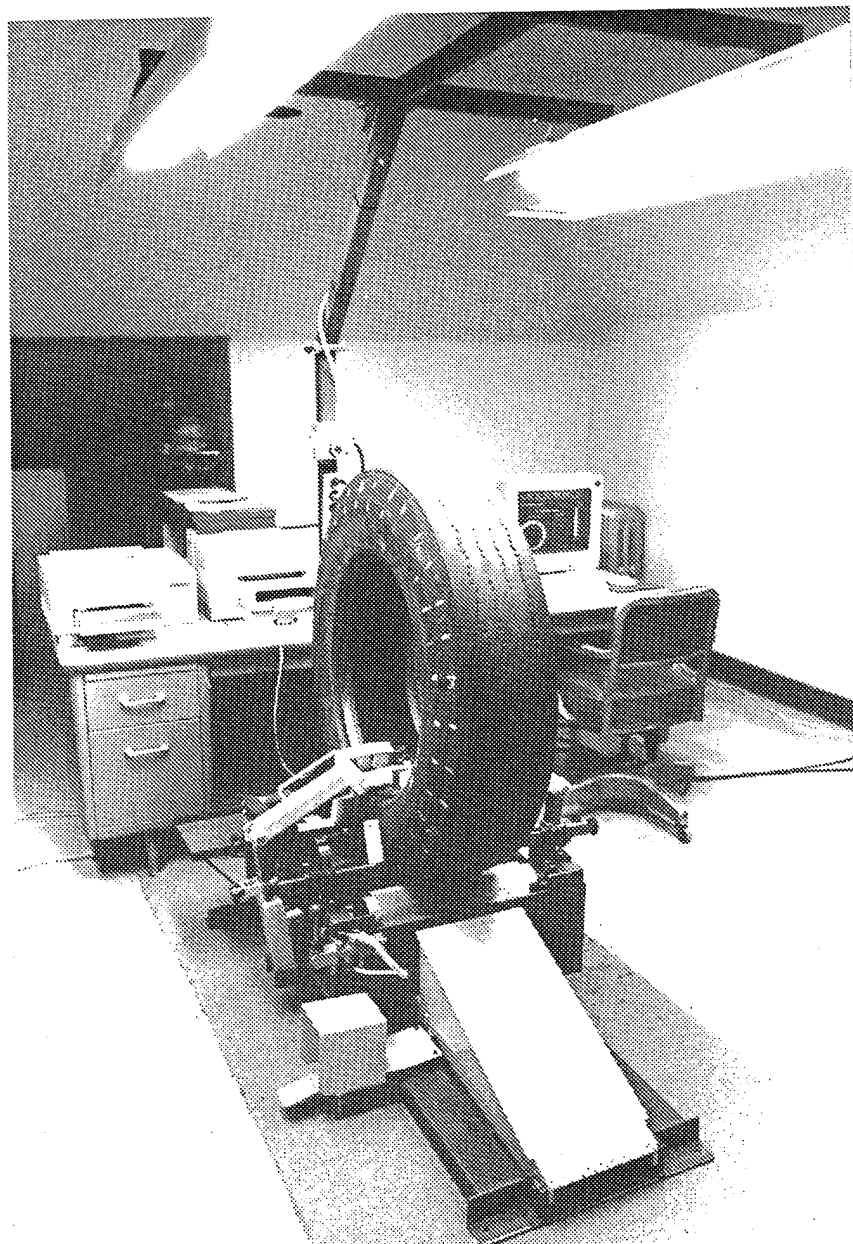
Figure 1 (a) Overall photograph of machine with tire

The base machine is a modified version of the INSTA-SPECT Inspection/Repair Station purchased from ATEC, Inc., a photograph of which is shown in Figure 1(a) with a tire in a mounted position. The internal components are shown in more detail in Figure 1(b). In its original form, this machine is used in industry for manual tire inspection and repair. The main features of the machine are the ramp, which facilitates tire placement onto the machine, the rollers, which rotate the tire during inspection, the spreader arms, which pull the sidewalls of the tire apart to enhance visibility of inner surfaces, and the compressed air motor and associated drivetrain, which drive the rollers.
